Icom IC-910H Low Power Output

by VA3DDN

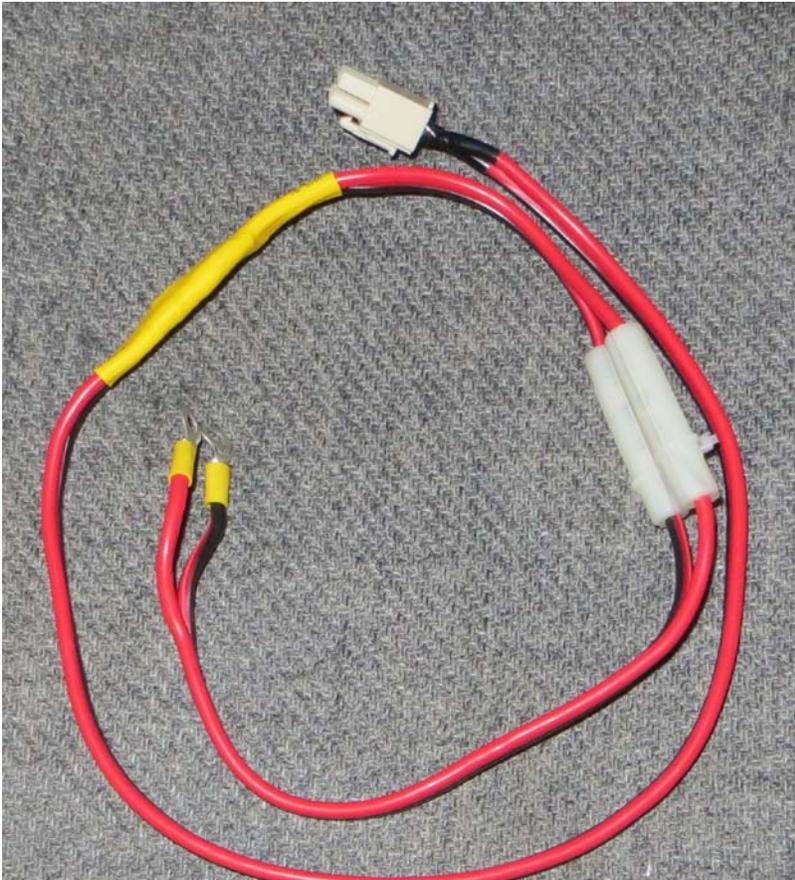
If so, some ham radio dealers carry the Jetstream JTPC1 replacement DC power cord, that has the correct radio connector plug and is made with **AWG #10** copper wire.

However, it is **too long** at 10 feet, for use with the IC-910A.

I cut mine down to about 39" overall, including splicing in the section with the in-line 30 amp fuse holders.

I cut off about 18" at the fuse holder end, and about 20" at the radio plug end and soldered them together using #10/12 butt splices.

Followed by a tape wrap and heat shrink tubing.
