# Alinco DR-235 Receiver Noise Fix

VA3DDN Dec 10, 2019

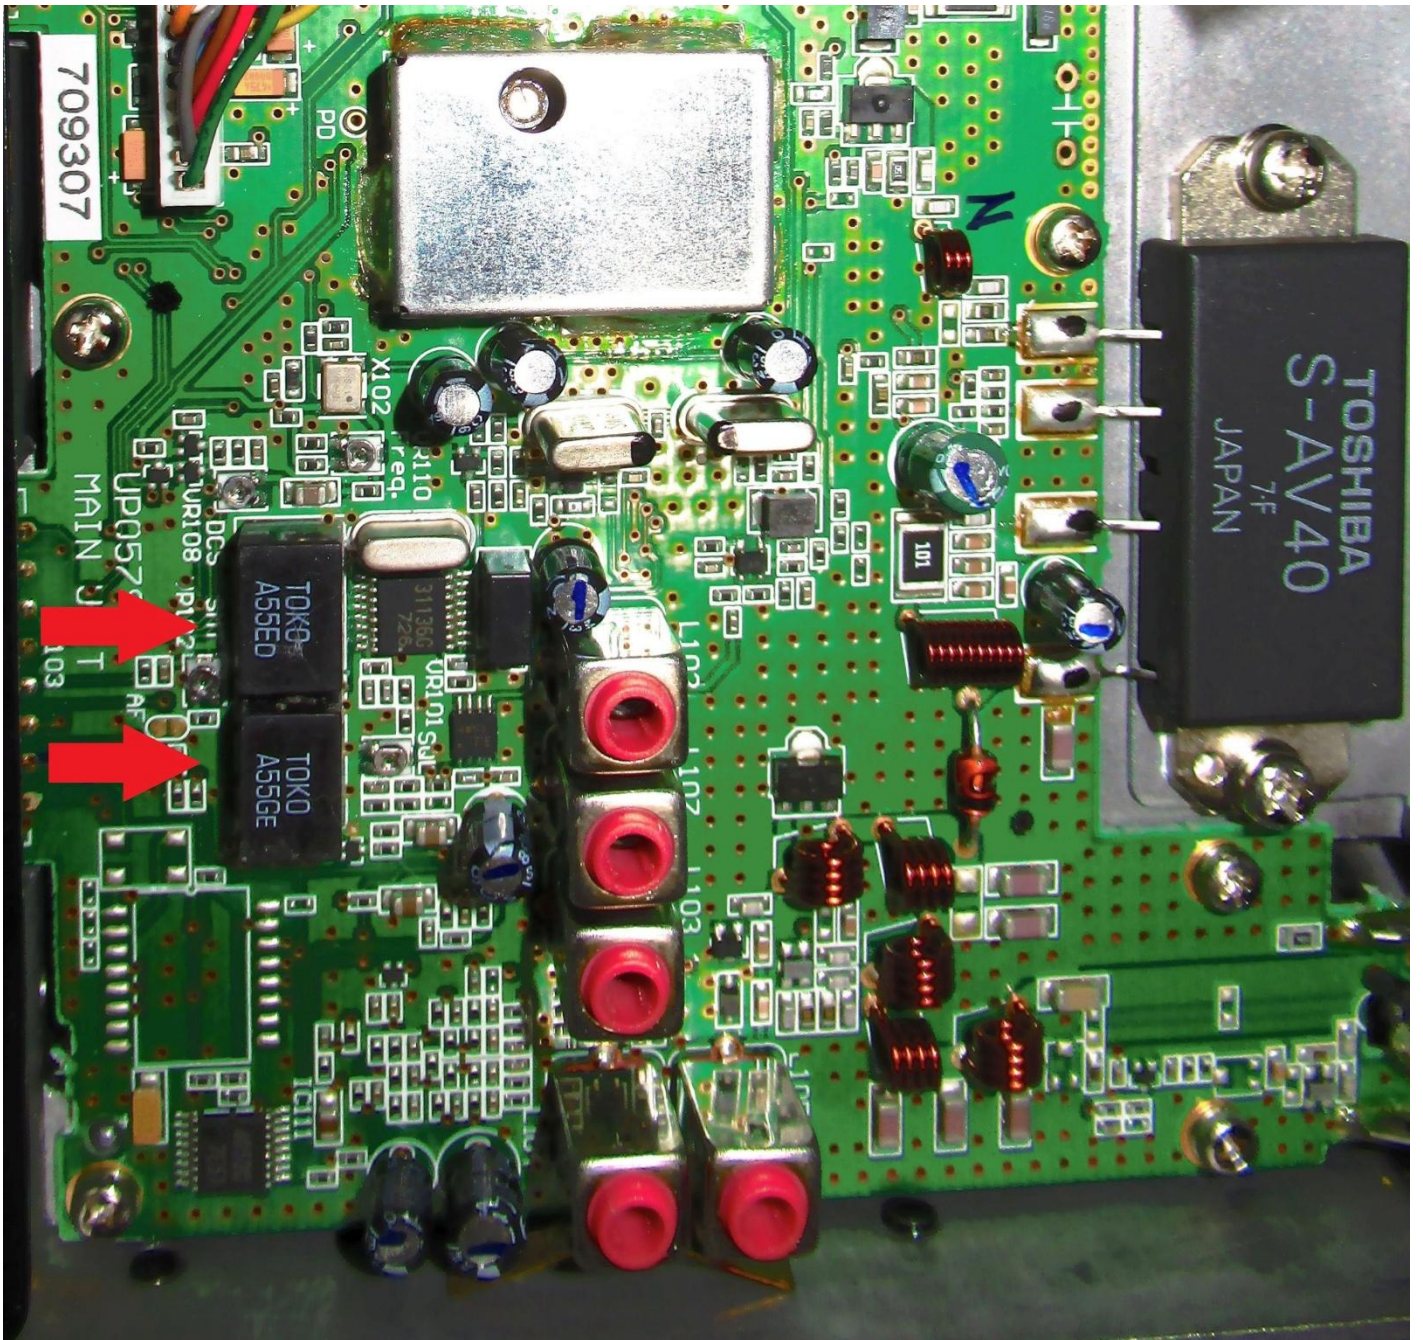
Photo follows p2

What attracted my eye was that the 2 band-pass ceramic filters, FL101 and FL102, indicated with the 2 red arrows on the photo below, seemed to have a light, frosty looking coating of some kind on their external surfaces. Enough so that the part number markings were not readily visible.

I don't have a very good explanation for this, but it seems likely to me that the “frosty look” was actually flux residues, likely so-called “No-clean”, that had become partially conductive through moisture adsorption. How did it get on to FL101/2 ? Don't know – just that my noise issue is completely gone.

I used several “Q-tip” cotton swabs moistened with isopropyl alcohol, and began to swab off the surfaces of FL101 and FL102 as well as the surrounding pcb areas.

.As I was doing this, the noise level suddenly disappeared completely and **has not returned!** Little was visible on the Q-tips, just some residue with a pale blue color.
