8-pin microphone connectors, round

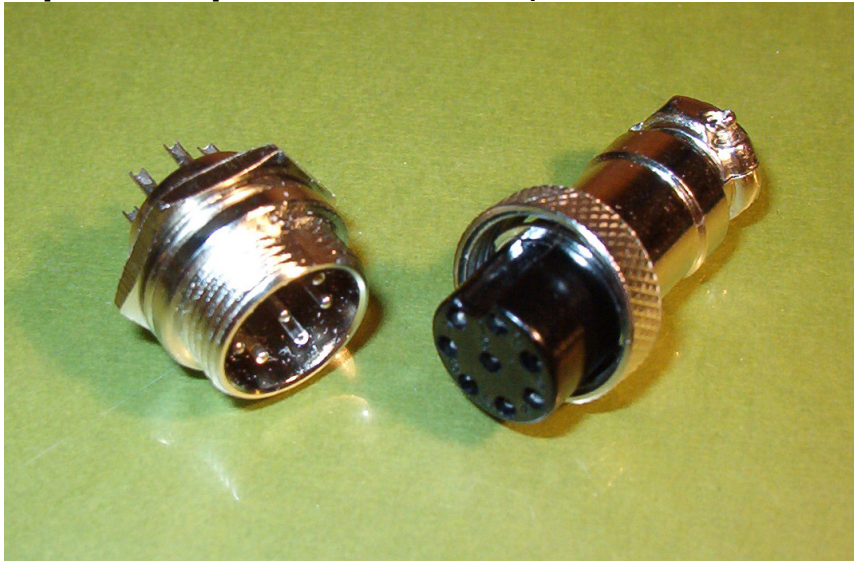
Look out for problems of fit, where the mating male pin and female terminal parts may be a loose fit.

In other words, the female connector terminals may not snugly fit the mating male chassis pins, resulting in intermittent connections that cannot be repaired.

A simple test is to break out one of the pins and use it as a go-no-go gage on each of the 8 socket terminals. If the pin has zero insertion force when tried in a terminal, that terminal is bad.
